PERTRONIC INDUSTRIES LTD

FIREBITS

September 2010

Pertronic F100 System In Northland Events Centre

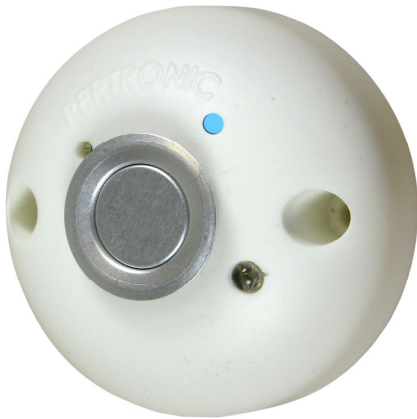
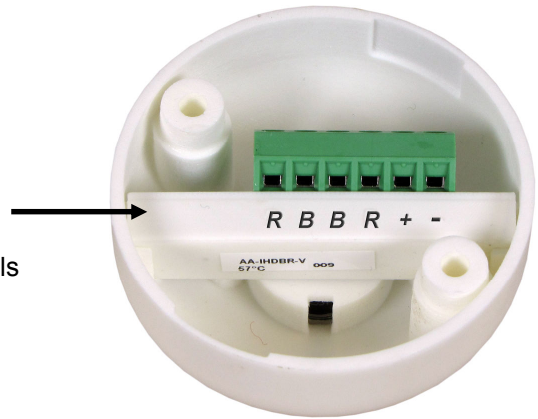
White cover for indicating models (remote indicating model shown)
Orange cover for non-indicating models

- A rounder, more stylish shape to the body.
- The Fire LED protrudes slightly from the detector's body for improved visibility.
- The horizontally mounted circuit board in existing models is replaced with a vertically mounted circuit board and protective cover to improve the detector's moisture resistance (note, however, this is not designed to replace the use of encapsulated detectors in wet areas). For ease of identification, indicating models have a white protective cover, while non-indicating models have an orange cover.
- A recessed 'test' LED is fitted to all models - both indicating and non-indicating. When the detection circuit polarity is reversed in the fire control panel, the amber 'test' LED operates on all detectors connected to that circuit - a very useful fault finding and commissioning tool.

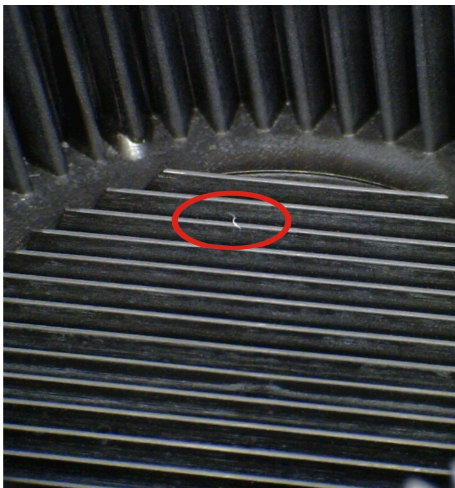
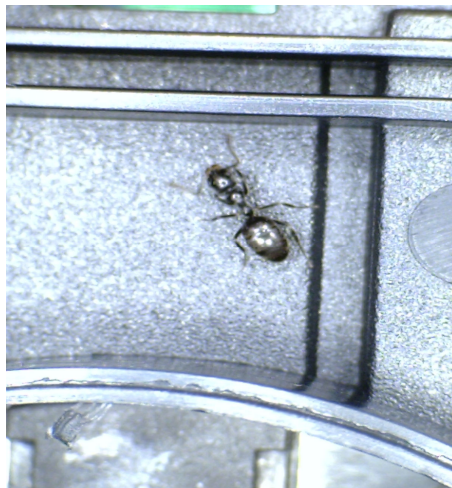
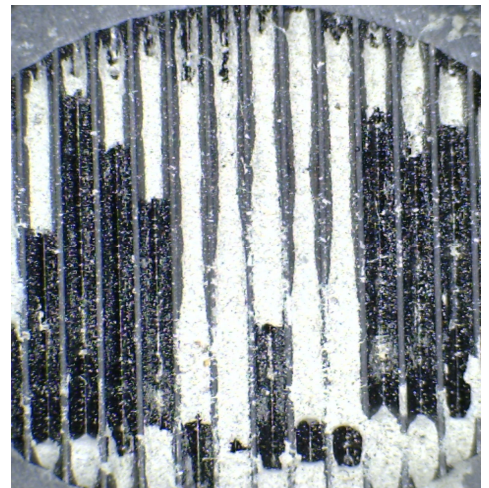
We often have smoke detectors returned which are said to have gone into alarm for “no apparent reason.” There is always a reason, and we find that some degree of detection chamber contamination is the most common reason. Sometimes the contamination may be difficult to see with a human eye (as with the carpet fibre), and microscopic examination may be required to identify the contaminant. In other cases, the contamination is more readily apparent, as with the other two photos below. In the photo to the right there was a huge build up of plaster dust (we suspect from the construction stage), while the ant in the middle photo was very much alive and active at the time the photo was taken. A small bug like this moving around inside the detection chamber will almost always trigger an alarm. Or the bug may have exited the chamber but left some residue behind (eg. eggs or cobwebs) and this residue is equally as likely to trigger an alarm.

Pertronic Industries Lower Hutt head office experienced a false alarm from a smoke detector at 3am one July morning. When the fire alarm operated – and called out the Fire Service – the building was completely empty (how often are we told this story by fire alarm companies?). The detector involved was in a carpeted office in part of the new factory extension (clue here – new carpet equals lots of loose fibres). The alarm occurred approximately one hour after the cleaners had vacuumed the office. When the detector was examined later that day under a digital microscope, a carpet fibre was found inside the chamber (lower left photo). These fibres can act like a ‘light tube,’ amplifying the LED light inside the detection chamber of a photoelectric detector. But we were puzzled as to how carpet fibres can get into ceiling mounted detectors.

It was identified that the cleaners, in common with cleaners the world over, use backpack-style vacuums, and this particular model has the exhaust venting upwards. Depending on the condition of the vacuum filter, a diverse range of fibres and other items get distributed under pressure towards the roof area where the smoke detectors are mounted. It is interesting that an hour passed from when the cleaners were creating disturbed (and contaminated) air movement to when the fibre in the detection chamber triggered an alarm .

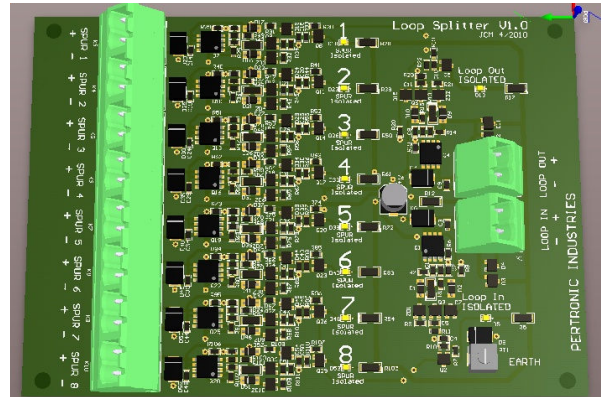
To simplify this conversion process Pertronic have developed an 8 Spur AA Isolator Board. This board allows the connection of eight spurs of analogue detectors and modules onto an analogue addressable system. The board can be fitted inside the new panel or further out in the installation on the data loop. Each spur termination has short circuit isolation from other spurs and from the rest of the data loop. Any spur with a short circuit present is identified by an amber LED indicator on the board, and no termination is needed for unused inputs. Product code is 8SAAIB.

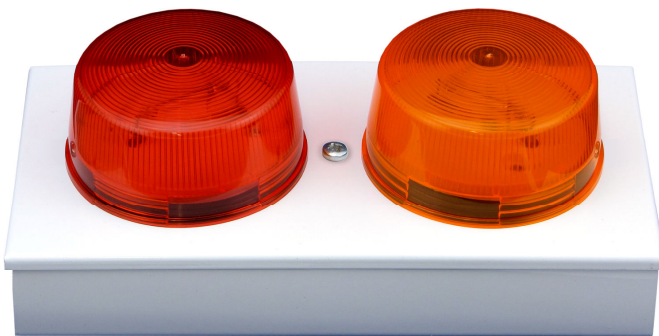
Pertronic have developed a Dual Alert-Evac Strobe to provide visual indication for evacuation systems where separate Evacuation or Alert visual warnings are required. The Dual Alert-Evac Strobe supports a 2, 3 or 4 wire connection to operate the amber or red strobe. In a 2-wire connection the selection of the coloured strobe is determined by the polarity of the DC voltage applied to the terminals. In a 3-wire connection (factory default setting), strobe selection is determined by voltage being applied to either the Evac or Alert terminal. In a 4-wire connection, two separate 2-wire sounder circuits are used for independent strobe control. The low profile two-part case enables the case to be easily mounted to walls or ceilings, and then accessed by the removal of one screw. Four knockouts are conveniently placed for ducted cabling.

Operating Voltage:	20Vdc to 30Vdc
Quiescent current:	0.2µA (at 24V)
Operating current:	50mA (at 24V)
Flash Rate:	1.1Hz (at 24V)
190 x 100 x 65	H x W x D mm
Product code:	DUALSTROBE
